**Flood Control Project Maintenance  
Levee Inspections****LMA District Cover Sheet****Spring 2011 Levee Inspection Results****Sutter Maintenance Yard Nelson Bend**

**Levee Inspection Report By Mile - Spring 2011**

**Sutter Maintenance Yard Nelson Bend**

Waterway							Bank	Unit Miles	Inspection Start/End	Inspector
Unit No. 01 Feather River West Levee-Nelson Bend								0.50	05/03/2011 05/03/2011	Clay Thomas
LMR No.	Levee Mile		Category	Item	Location	Rating	Action/Comment	GPS Latitude/Longitude		Issue No.
	Start	End						Start	End	Photo
1	0.01	0.45	Earthen Levee	Vegetation	WS	M	Remove the wild growth other than native grasses from the levee slopes.	38.886940 ° -121.614755 °	38.880855 ° -121.614555 °	2 Y
2	0.01	0.45	Earthen Levee	Vegetation	LS	M	Remove the wild growth other than native grasses from the levee slopes.	38.886937 ° -121.614752 °	38.880822 ° -121.614565 °	1 Y
3	0.01	0.45	Earthen Levee	Trim / Thin Trees	LS	M	Thin trees to allow visibility of the ground and room to flood fight.	38.886933 ° -121.614753 °	38.880857 ° -121.614555 °	3
4	0.03	0.45	Earthen Levee	Crown Surface / Depressions / Rutting	CR	M	Add appropriate gravel or road base. Grade and compact.	38.886748 ° -121

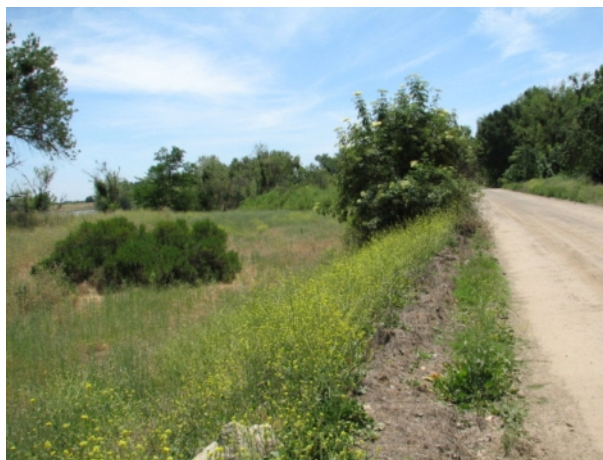
Levee Mile Report Line	1
Start Levee Mile	0.01
End Levee Mile	0.45
Location	Water Side
Category	Earthen Levee
Item	Vegetation

Water side vegetation levee mile 0.01.

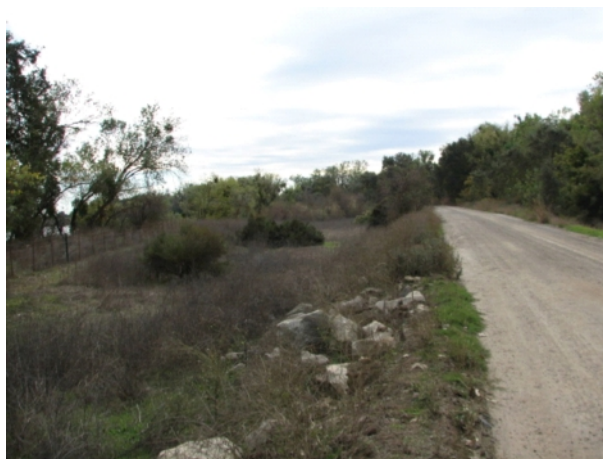
Levee Mile Report Line	1
Start Levee Mile	0.01
End Levee Mile	0.45
Location	Water Side
Category	Earthen Levee
Item	Vegetation

Levee mile 0.00, water side vegetation.

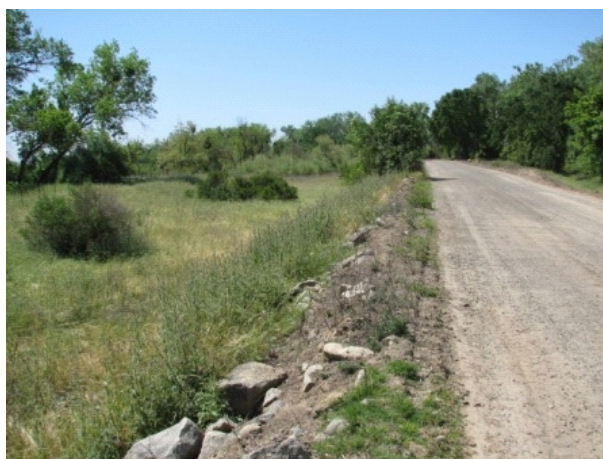
Levee Mile Report Line	1
Start Levee Mile	0.01
End Levee Mile	0.45
Location	Water Side
Category	Earthen Levee
Item	Vegetation

Levee mile 0.00, this photo is of the waterside vegetation.

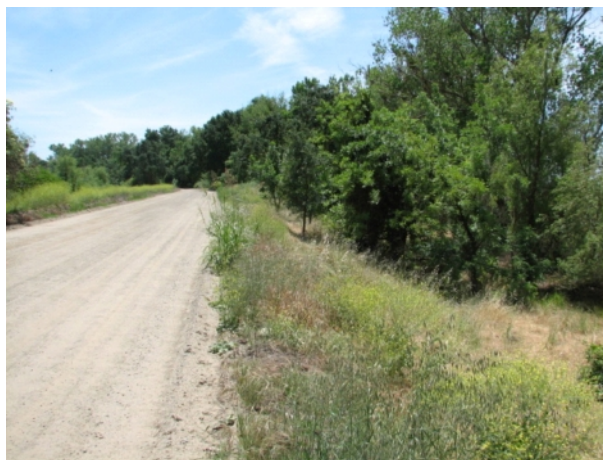
Levee Mile Report Line	2
Start Levee Mile	0.01
End Levee Mile	0.45
Location	Land Side
Category	Earthen Levee
Item	Vegetation

Land side vegetation levee mile 0.01.

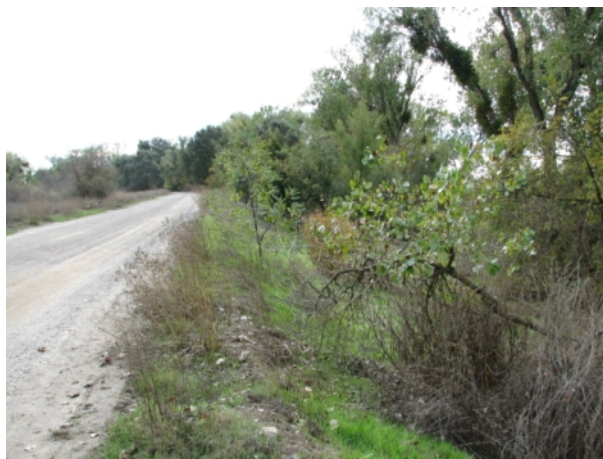
Levee Mile Report Line	2
Start Levee Mile	0.01
End Levee Mile	0.45
Location	Land Side
Category	Earthen Levee
Item	Vegetation

Levee mile 0.00, land side vegetation.

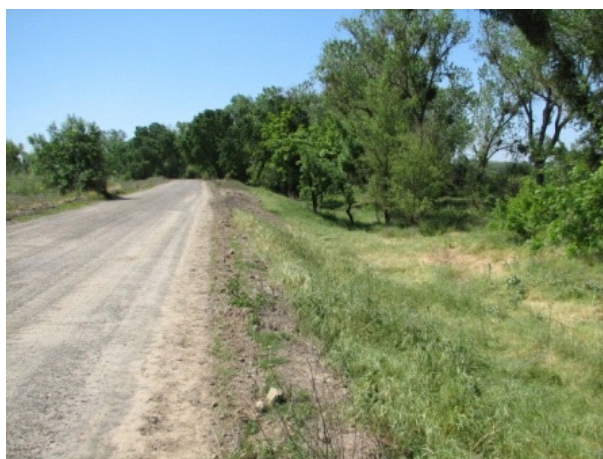
Levee Mile Report Line	2
Start Levee Mile	0.01
End Levee Mile	0.45
Location	Land Side
Category	Earthen Levee
Item	Vegetation

Levee mile 0.00, this photo is looking at the vegetation on the landside slope.
